## CROWN EAGLE RESTORATION

# Wood shake roof condition report

Visual assessment, photographs and preserve / repair / replace options.

Report prepared: October 12, 2026

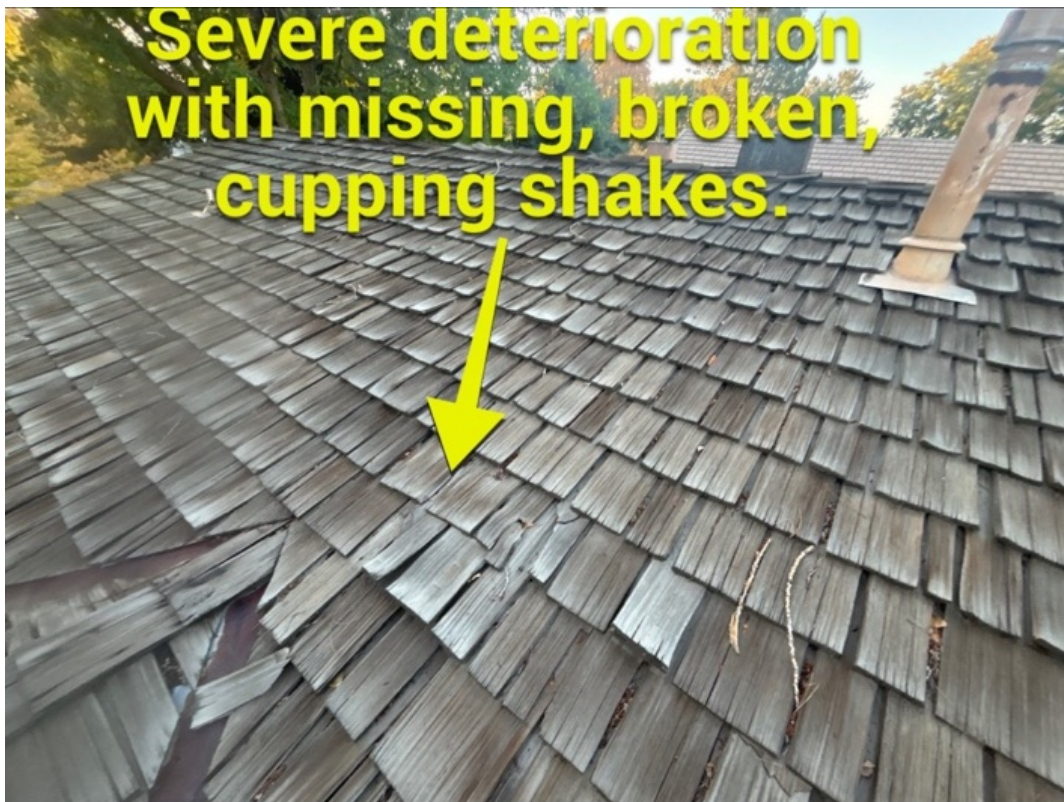
**PHOTO 01 / FIELD SHAKE CONDITION**

Missing or fragmented wood, broken ends and uneven course edges are documented in several photographed sections.

The yellow arrow identifies a visibly disrupted section of the covering. Broken and irregular ends are present around it. The original annotation describes missing, broken and cupped shakes.

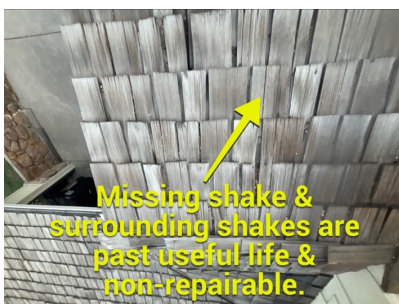
**PHOTO 02 / ANNOTATED CLOSE VIEW**

The supplied annotation identifies a missing piece and questions the surrounding wood's repairability. The photograph does not test the wood's ability to hold a fastener.

Silver-gray color and ordinary surface checking alone are not treated as roof failure. The concern is missing, fragmented or displaced material and its connection to adjoining courses.

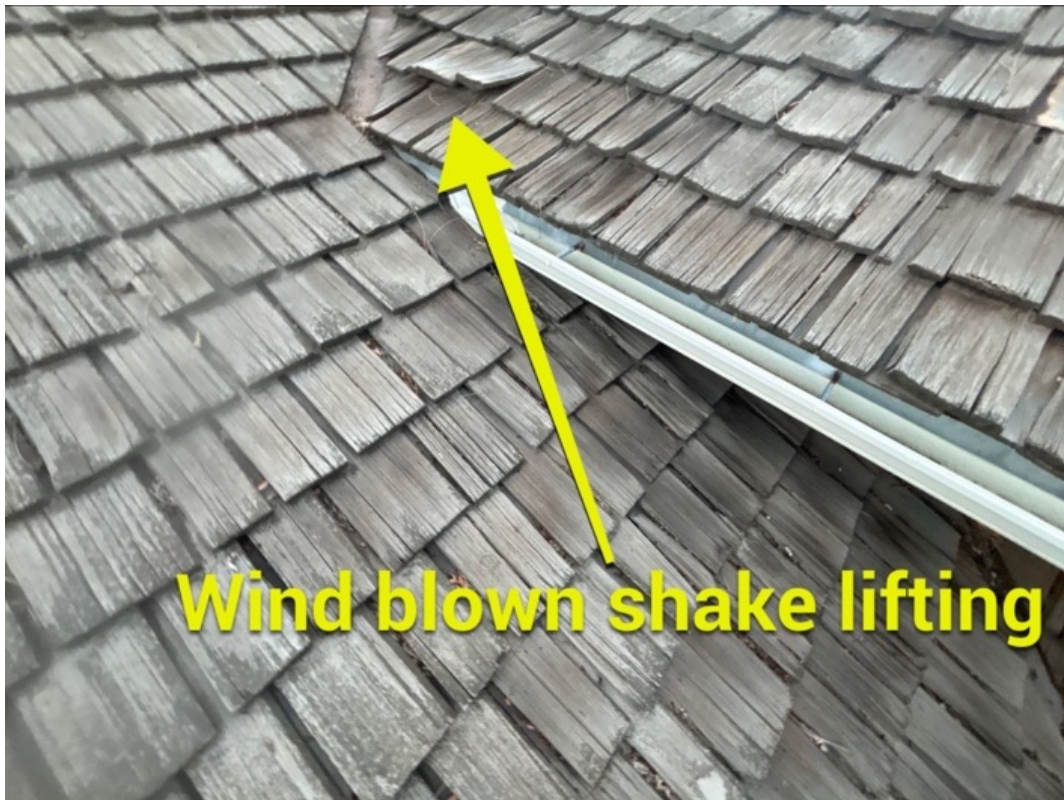
**PHOTO 03 / LIFTED SHAKE**

Raised shake edges interrupt the normally overlapping covering. The photographs do not establish the event or date responsible.

The arrow points to a raised piece beside the upper collection edge. The original annotation attributes the lift to wind; this image records position and does not independently establish storm causation.

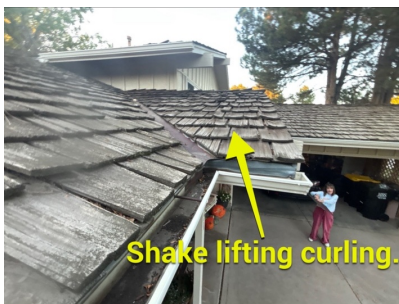
**PHOTO 04 / EAVE-SIDE CURLING**

The arrow identifies lifting and curling near the roof edge. Confirm attachment, overlap and the condition of neighboring shakes before selecting a repair.

Neither an active interior leak nor a particular loss date is established by these photographs.

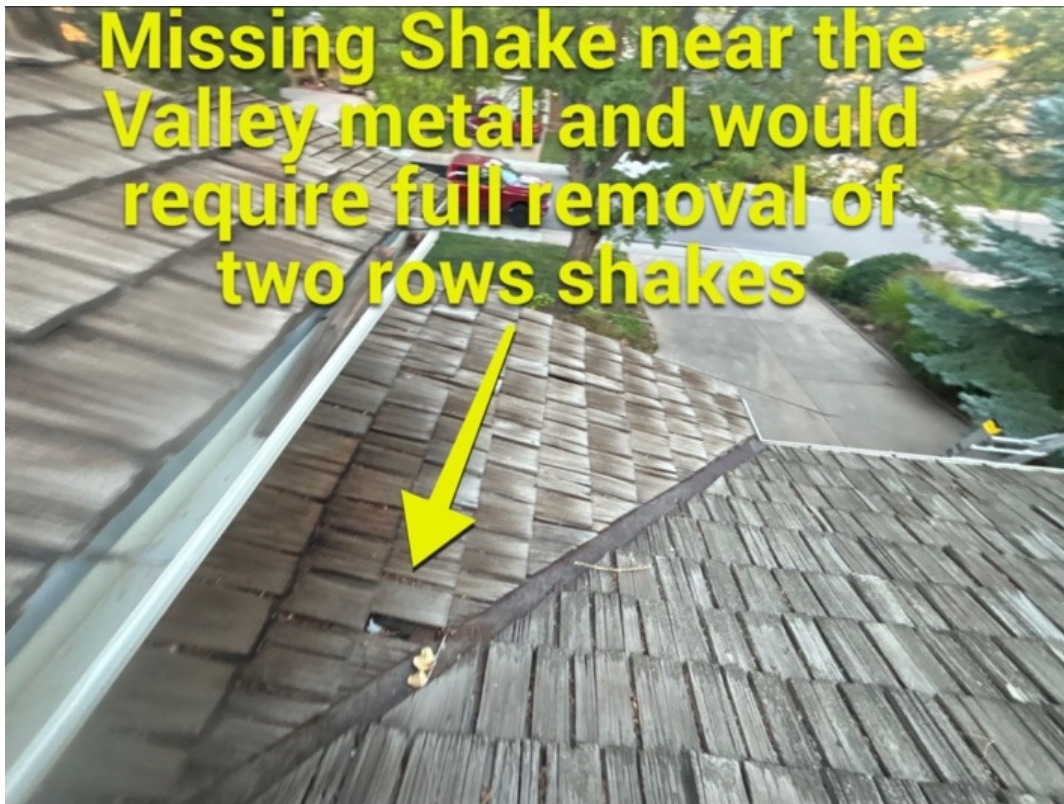
**PHOTO 05 / MISSING SHAKE NEAR VALLEY**

The annotations identify a missing shake near valley metal. Close views show localized wood loss and debris beside the channel.

The original annotation anticipates removal of two shake rows around the identified opening. That is a proposed field repair extent, not a measured or approved scope.

Confirm the actual repair boundaries on site. A localized opening does not establish that every adjoining course or the concealed deck requires replacement.

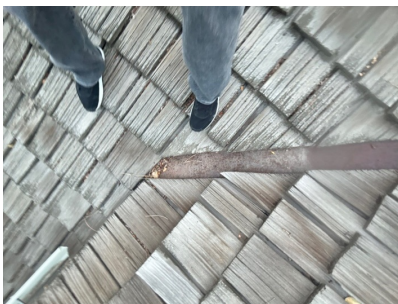
**PHOTO 06 / VALLEY CLOSE VIEW**

Exposed metal, debris and irregular wood ends are visible at the roof intersection. An open metal valley is a normal design feature; exposed metal alone is not labeled a defect.

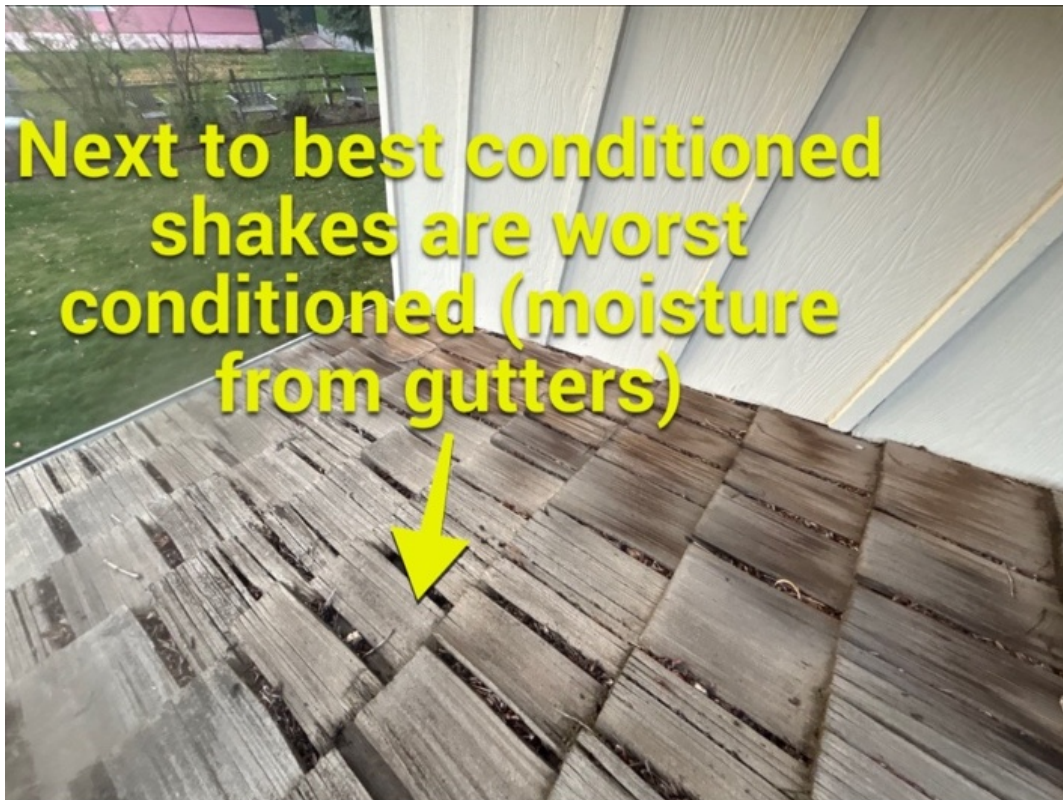
**PHOTO 07 / FRAGMENTED WALL-SIDE COURSES**

Heavily fragmented courses occur next to comparatively intact-looking pieces at an upper-wall transition. Drainage needs evaluation.

Openings, fragmented edges and debris are visible near the wall. The original note attributes this condition to moisture from gutters. No moisture readings or rain-flow test accompany the record.

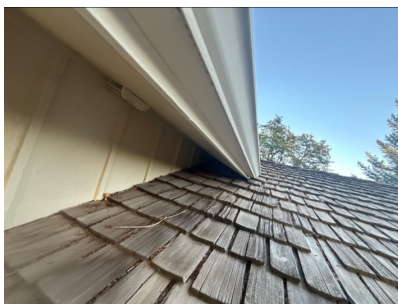
**PHOTO 08 / WALL AND UPPER EAVE**

Some pieces look more intact than neighboring pieces. Appearance alone does not verify remaining wood thickness, concealed decay or fastener holding capacity.

The wider view records how the shakes meet the wall beneath the upper eave. Check flashing, gutter discharge and the actual water path during the site evaluation.

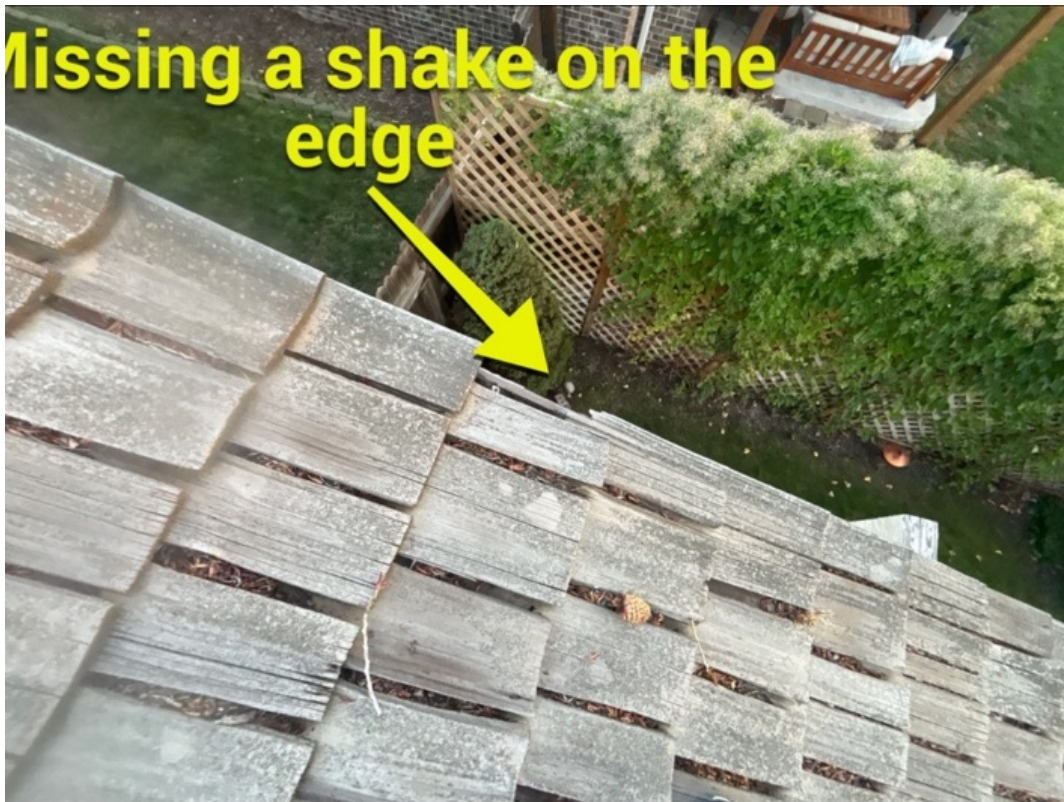
**PHOTO 09 / MISSING EDGE PIECE**

The original arrow identifies a missing shake at the photographed edge. Document the adjacent course ends, attachment and edge details before setting the repair boundary.

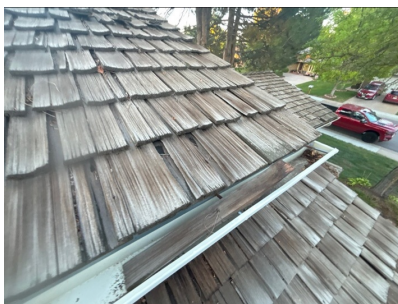
**PHOTO 10 / GUTTER AND SHAKE EDGE**

Leaves and debris are visible in the gutter. This view does not establish whether the gutter overflows during rain, or verify every concealed edge-flashing detail.

Inspect the gutters and downspouts as part of the roof plan. Their condition and discharge path should be recorded separately from the shake replacement scope.

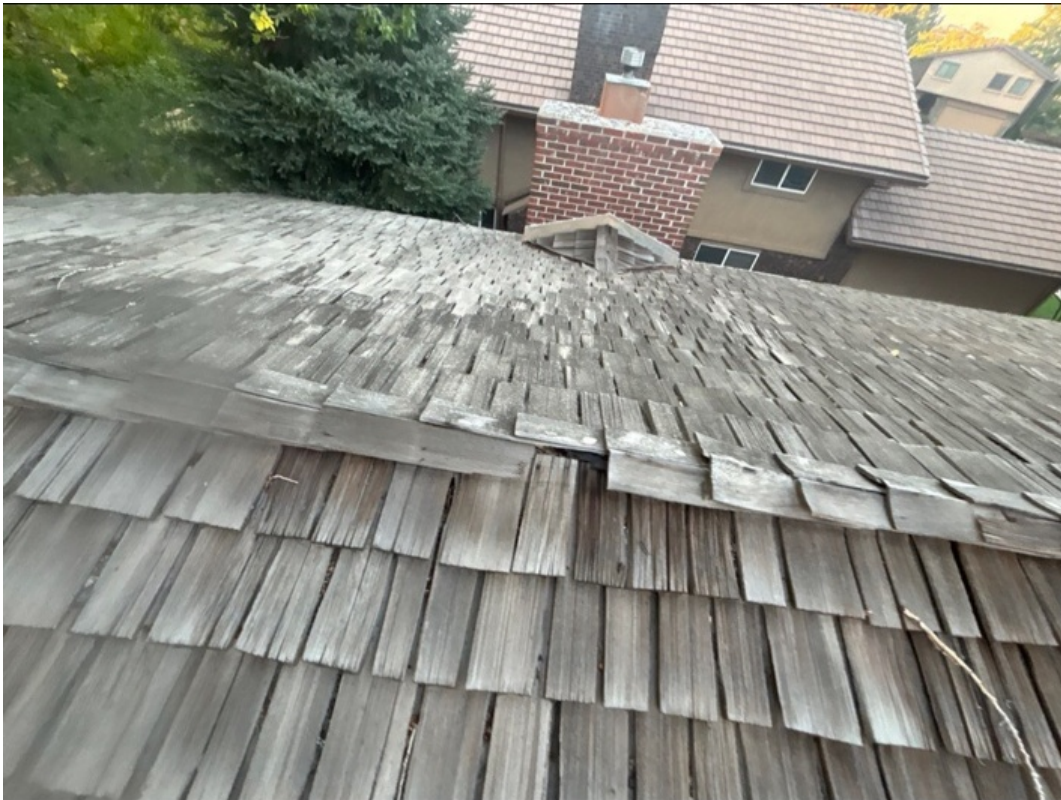
**PHOTO 11 / OPEN CAP JOINT**

A dark opening is visible at the butt joint between cap pieces. Adjoining shakes show irregular and fragmented edges. Concealed underlayment and attachment are not visible.

The record does not establish that every cap has failed, nor that an active leak exists beneath the photographed joint.
