## CROWN EAGLE RESTORATION

# Wood shake roof condition report

Visual Assessment & Recommendations

Field review: September 28, 2026 / Updated: October 9, 2026

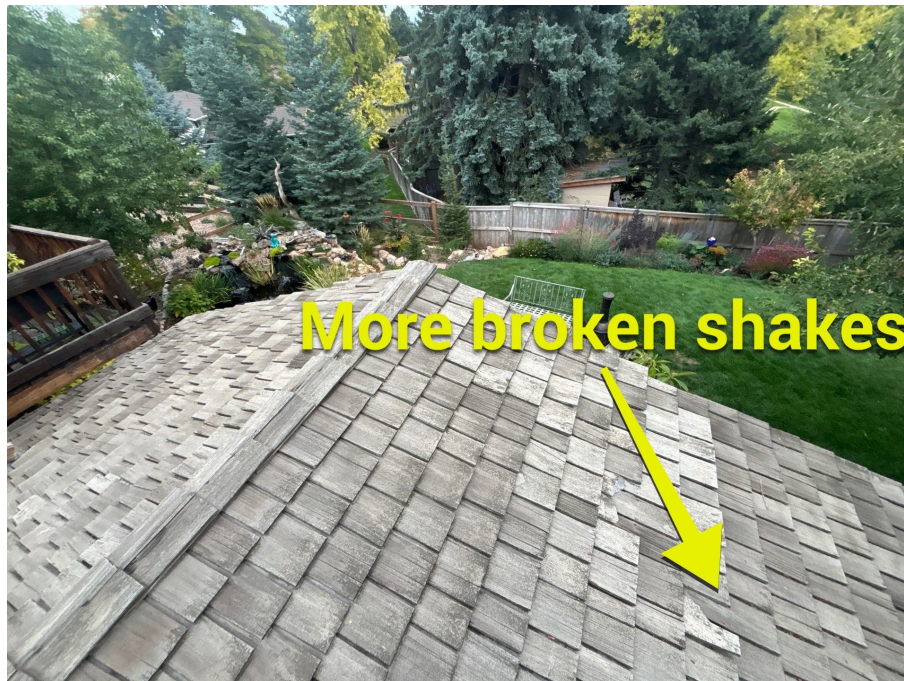
**PHOTO 01 / LOWER SLOPE**

Broken and irregular shake ends are documented on the lower slope. The yellow arrow and wording are original field annotations.

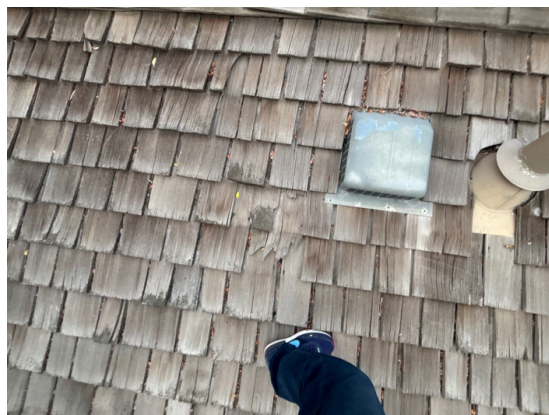
**PHOTO 02 / VENT AND PIPE AREA**

The close view shows weathered, ragged edges and a split piece near the roof penetrations. Color and ordinary checking alone are not treated as evidence of failure.

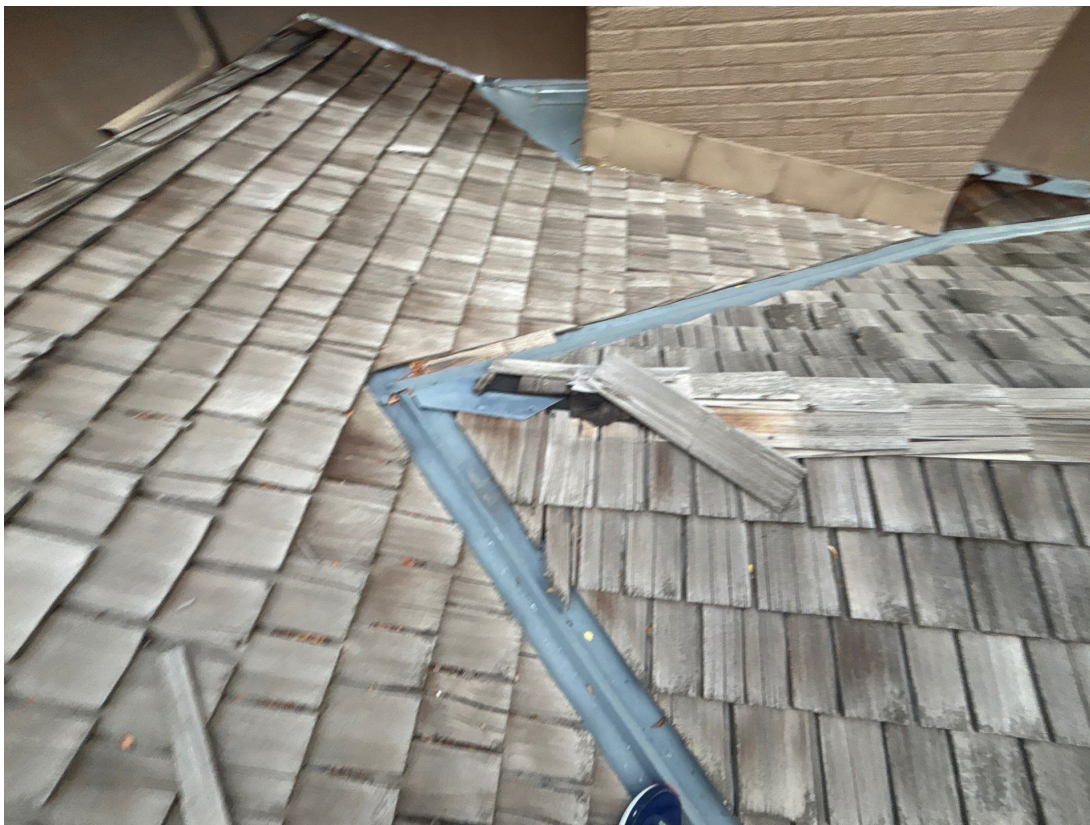
**PHOTO 03 / CAP-VALLEY JUNCTION**

A cap piece is displaced, loose wood rests on the roof, and an opening is visible beneath the interrupted cap assembly. The exposed metal valley channel itself is not labeled a defect.

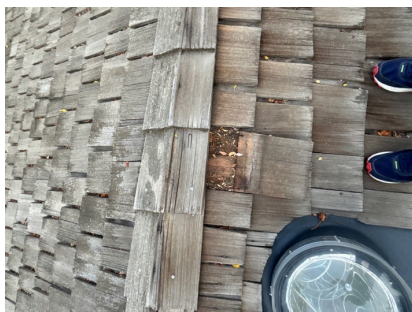
**PHOTO 04 / CAP DETAIL**

A closer view records a gap beside the cap and nearby fragmented wood. The image does not reveal the condition of the concealed underlayment, deck or fasteners.

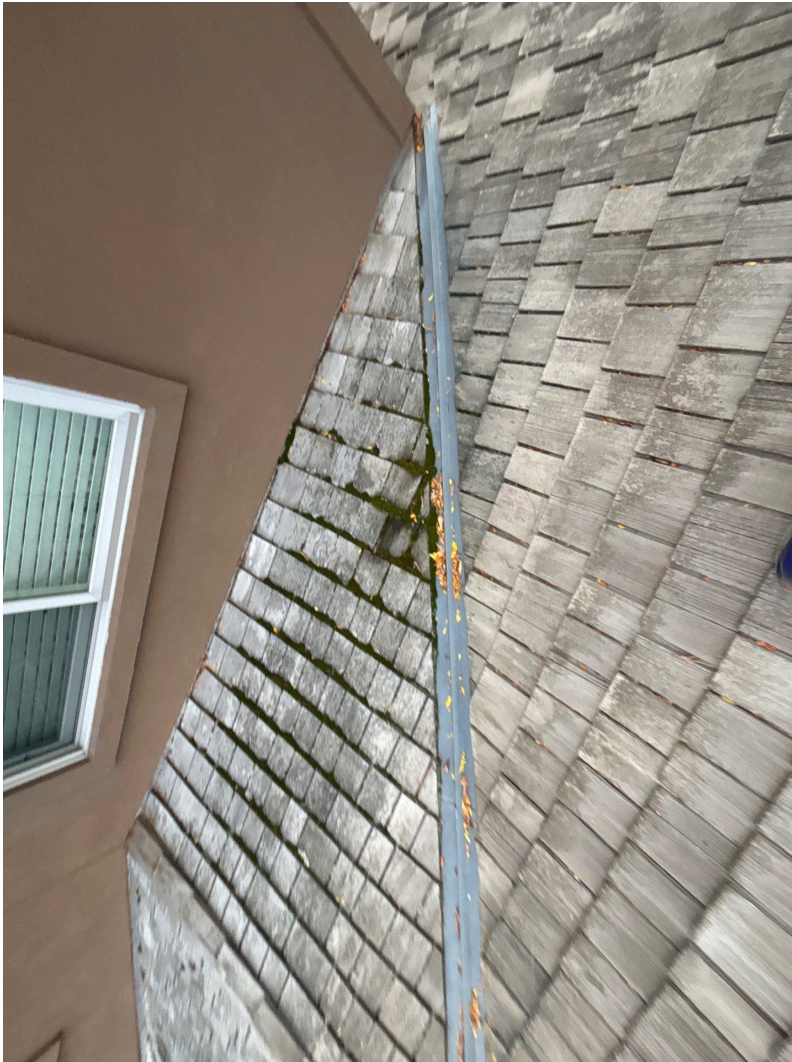
**PHOTO 05**

Green moss-like growth is present along several shake-course edges beside the stucco wall and metal valley.

Benjamin's annotated notes identify this section as receiving gutter overflow and describe moss and deterioration in the area.

Take and document moisture readings in affected shakes and inspect adjoining wood. No moisture readings have been taken. Moss alone does not establish decay.

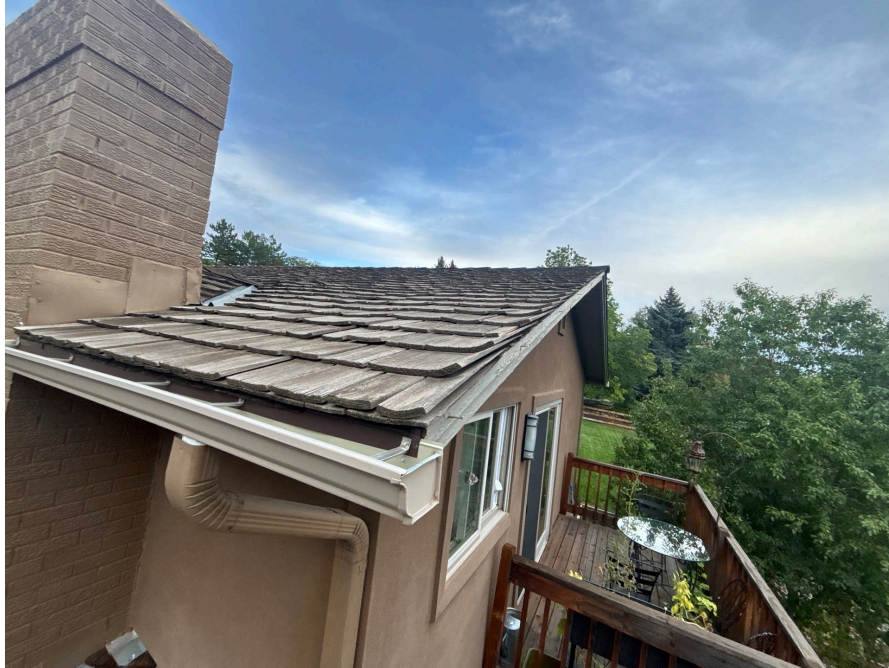
**PHOTO 06 / UPPER GUTTER CONNECTION**

The upper gutter connects to a downspout running along the wall above the lower shake roof.

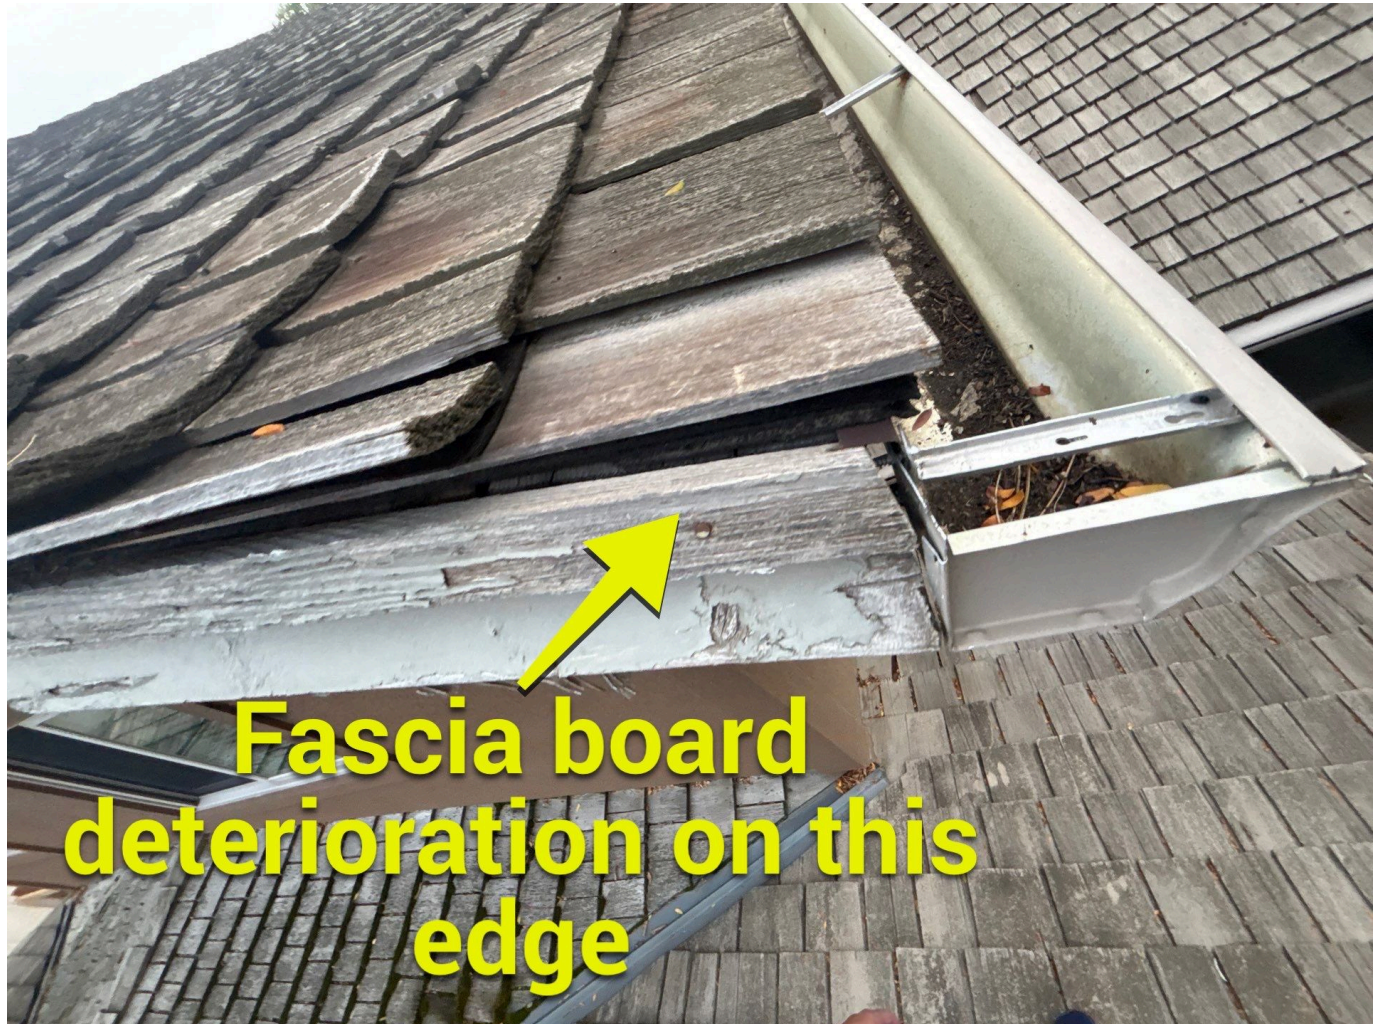
**PHOTO 08 / PHOTOGRAPHED EAVE**

The fascia coating is peeling, with exposed, rough and locally irregular wood. Benjamin's original note identifies deterioration at this edge. Leaves and other debris are visible in the adjoining gutter.

This is a localized visual observation. The photograph does not establish the depth of wood deterioration, concealed attachment condition or the condition of every fascia board and gutter.

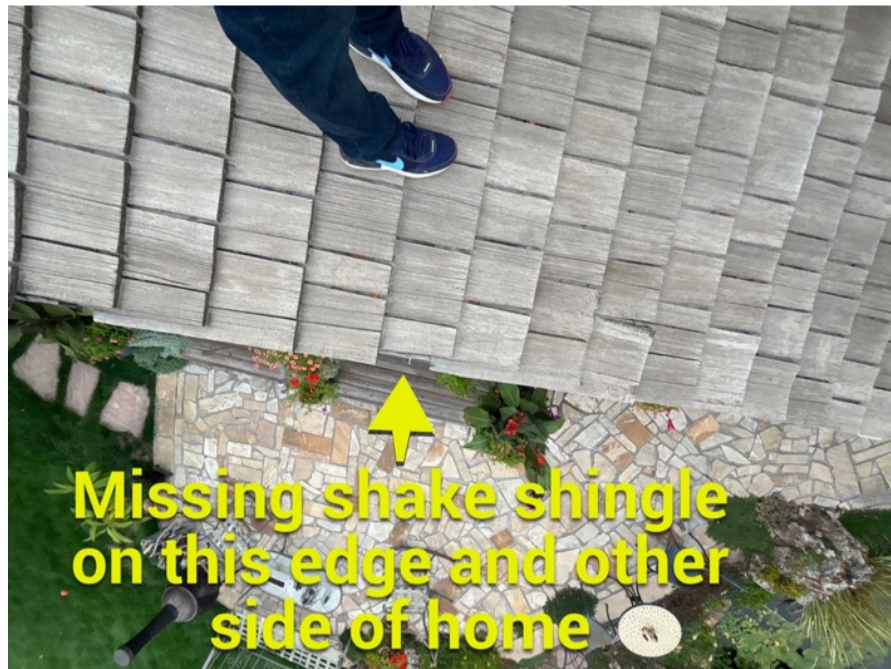
**PHOTO 09 / EAVE OVER PATIO**

Benjamin's original arrow identifies a locally missing shake at the photographed roof edge. The annotation also records his observation of another area; that other area is not shown in this image.

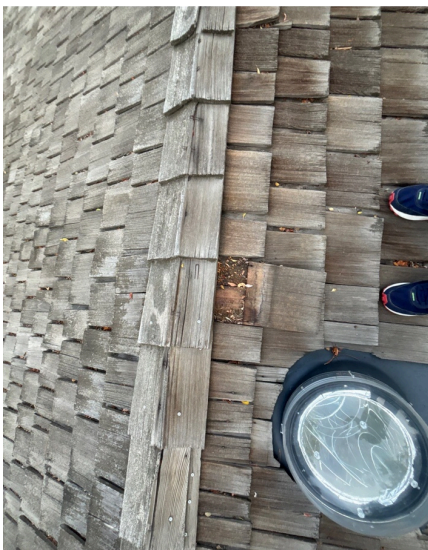
**PHOTO 10 / DAYLIGHT UNIT**

The close view records the shake courses beside the tubular daylight dome and adjoining cap line. Irregular course ends and a local opening beside the cap are visible.

The photograph does not establish the concealed flashing arrangement, watertightness or the cause of the marks on the dome.
